MTL TR 89-68

# EFFECTS OF HOT CORROSION ON THE ROOM TEMPERATURE STRENGTH OF STRUCTURAL CERAMICS

JEFFREY J. SWAB

July 1989

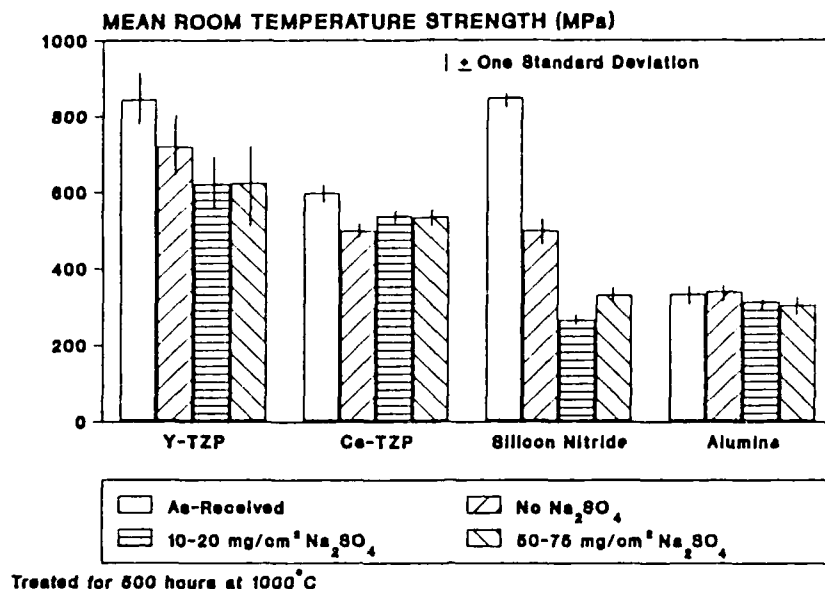
Figure 1. Mean room temperature strength after corrosion with and without sodium sulfate.

The results of the room temperature flexure strength testing, Figure 1, show the Ce-TZP to be the most resistant to strength degradation after exposure to molten sodium sulfate at 1000°C, followed by the alumina and the Y-TZP. The  $\text{Si}_3\text{N}_4$  shows the largest strength loss after exposure.

The slight strength reduction of the Ce- and Y-TZP after 500 hours at 1000°C without  $\text{Na}_2\text{SO}_4$  can be attributed to the fact that these materials are transformation-toughened ceramics and are susceptible to overaging when exposed to elevated temperatures for a prolonged time. The addition of a small amount of a rare earth oxide, such as  $\text{CeO}_2$  or  $\text{Y}_2\text{O}_3$ , along with an appropriate processing technique, allows for the retention of metastable tetragonal zirconia at room temperature. However, when overaging occurs, the tetragonal zirconia transforms to the stable monoclinic phase, resulting in a reduction in strength.<sup>15-18</sup>

The  $\text{Si}_3\text{N}_4$  has a significantly large reduction in strength (~40%) when exposed to the same treatment conditions. An oxidized layer of  $\text{SiO}_2$  forms when  $\text{Si}_3\text{N}_4$  is exposed to temperatures in excess of 1000°C for a prolonged time<sup>20,21</sup> (Figure 2b). The loss of strength is due to the creation of oxidation pits as shown in Figure 3b. Alumina does not undergo phenomena such as these. Thus, there is no reduction in strength as a result of this exposure.

The addition of  $\text{Na}_2\text{SO}_4$  to the long time/high temperature exposures does not cause any further strength reduction in the Ce-TZP, and only minimal reduction in the alumina. However, the Y-TZP and, to a greater extent, the  $\text{Si}_3\text{N}_4$  experience significant reductions in strength.

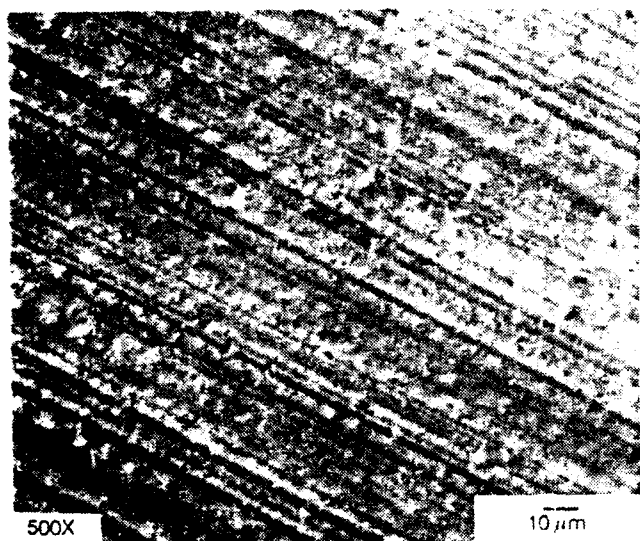
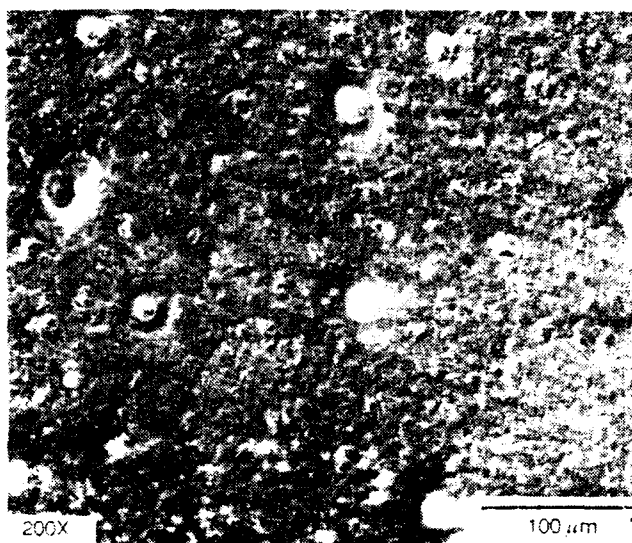
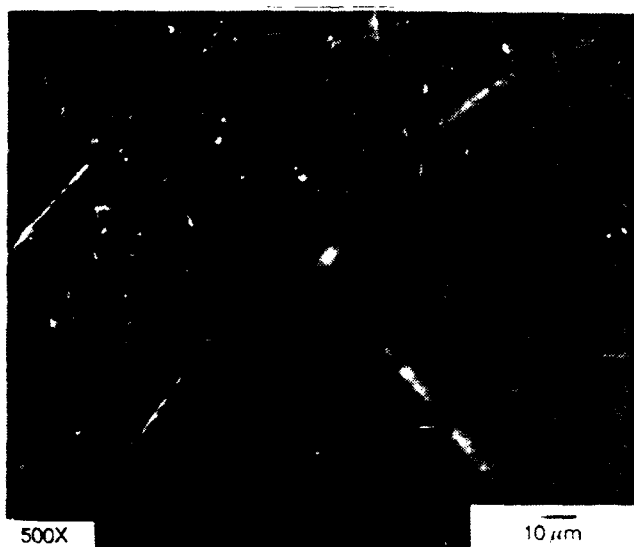
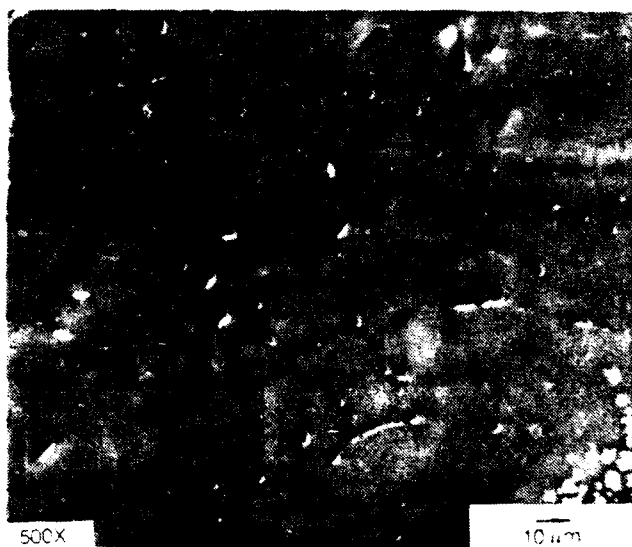
(a) As-Received

(b) After 500 Hours at 1000°C without  $\text{Na}_2\text{SO}_4$

(c) After 500 Hours at 1000°C with 10 to 20  $\text{mg}/\text{cm}^2$   $\text{Na}_2\text{SO}_4$

(d) After 500 Hours at 1000°C with 50 to 75  $\text{mg}/\text{cm}^2$   $\text{Na}_2\text{SO}_4$

Figure 2. Tensile surfaces of  $\text{Si}_3\text{N}_4$ .

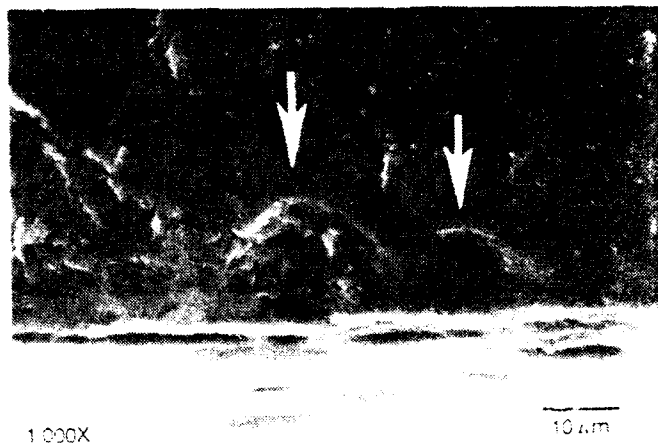
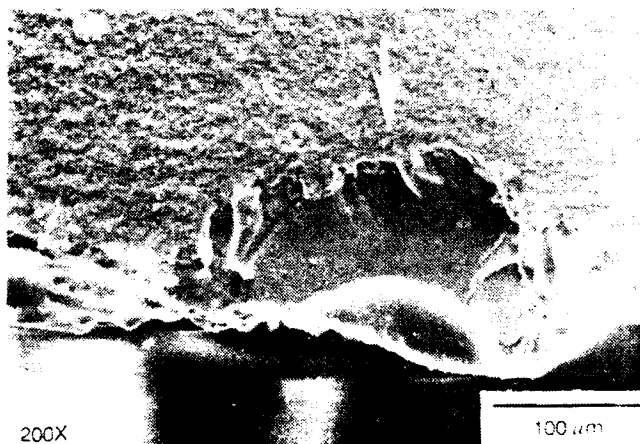
(a) As-Received - Machining Damage

(b) After 500 Hours at 1000°C without  $\text{Na}_2\text{SO}_4$  - Oxidation Pits

(c) After 500 Hours at 1000°C with 10 to 20  $\text{mg}/\text{cm}^2$   $\text{Na}_2\text{SO}_4$  - Corrosion Pits

(d) After 500 Hours at 1000°C with 50 to 75  $\text{mg}/\text{cm}^2$   $\text{Na}_2\text{SO}_4$  - Corrosion Pits

Figure 3. Fracture origins of silicon nitride. Note the change in magnification from (a) and (b) to (c) and (d).

Examination of the fracture surfaces of the TZPs and the alumina showed that the type of strength-limiting flaw did not change after exposure to molten sodium sulfate, Figures 5 through 7. This was not the case for the  $\text{Si}_3\text{N}_4$ . It experienced an additional strength loss of ~25% when exposed to  $\text{Na}_2\text{SO}_4$ , due to a change in the flaw type and size. The typical flaw for the as-received material was machining damage, Figure 3a, and that for the bars treated without any  $\text{Na}_2\text{SO}_4$  was oxidation pits, Figure 3b. For the bars exposed to  $\text{Na}_2\text{SO}_4$ , the flaw also a pit, but this time a corrosion pit, Figures 3c and 3d, which are on the order of 10 times larger than the oxidation pits. Analysis of the pit contents showed the presence of a small amount of Na in addition to Si and Mg. The presence of Na, as well as the glassy-like appearance of the contents of the corrosion pit, indicates that a sodium-silicate glass has been formed as outlined in Equation 5. The Mg is due to the addition of MgO as a hot-pressing aid.

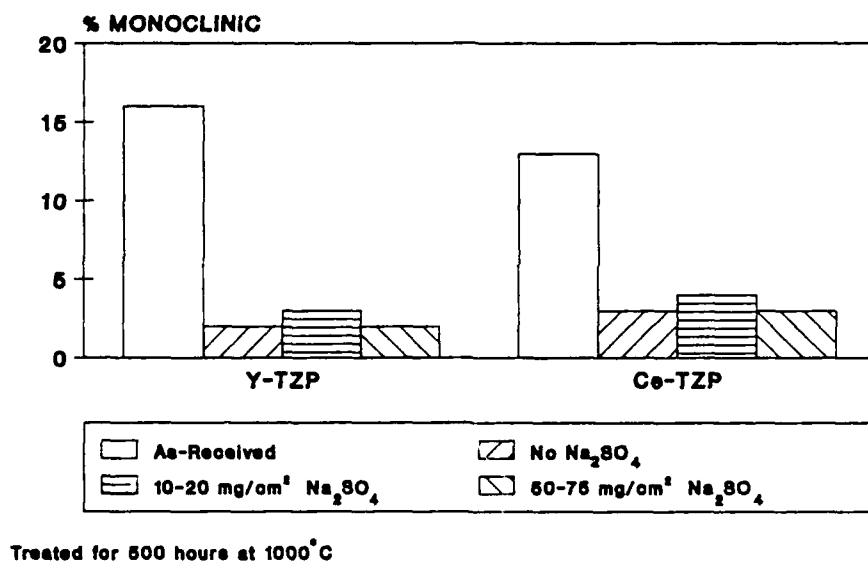
Figure 4. Surface phase stability of Y-TZP and Ce-TZP after thermal exposure with and without sodium sulfate.

Figure 4, shows the phase stability of the TZPs. The high amount of monoclinic  $ZrO_2$  in the as-received TZPs can be attributed to the stresses placed on the surface of the bar during machining. These stresses transform the surface  $ZrO_2$  from tetragonal to monoclinic. Subsequent treatments at 1000°C relieves the stresses allowing most of the monoclinic grains to revert to tetragonal grains.

One would expect an increase in the monoclinic  $ZrO_2$  as the  $Y_2O_3$  was being leached from the surface. However, since this potential phenomenon only occurs in the first few layers of this fine-grained material, ( $\sim 0.2 \mu m$ )<sup>15</sup> due to the small amount of  $Na_2SO_4$ , the resolution of the X-ray diffraction equipment is probably not sensitive enough to pick up these changes. In addition, flexure testing is sensitive to surface flaws rather than volume flaws. Thus, during high temperature corrosion, the corrosive material may penetrate in and around these flaws causing several layers of grains to transform and enhancing the severity of the flaws. This potential flaw enhancement may not be discernible in routine examinations. Chemical analysis of the remaining sodium sulfate after treatment would be a more significant measure of the leaching phenomenon and resultant phase transformation.

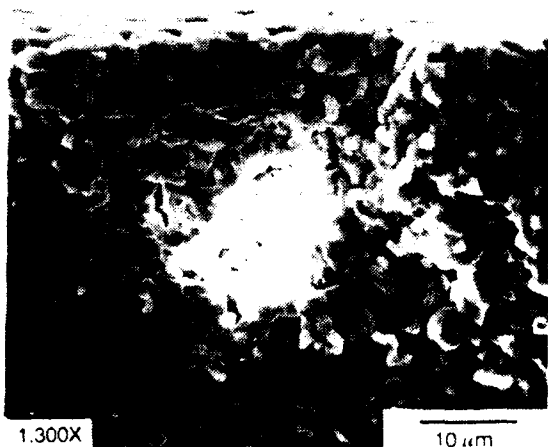
(a) As-Received

(b) After 500 Hours at 1000°C with  $\text{Na}_2\text{SO}_4$

Figure 7. Fracture origins of alumina - pores.
